Bob Backstein Corporation

Rewolinski Roof Inspection

April 28, 2011

I performed a roof inspection for Richard Rewolinski at 6408 49th Street West, University Place, WA 98467.

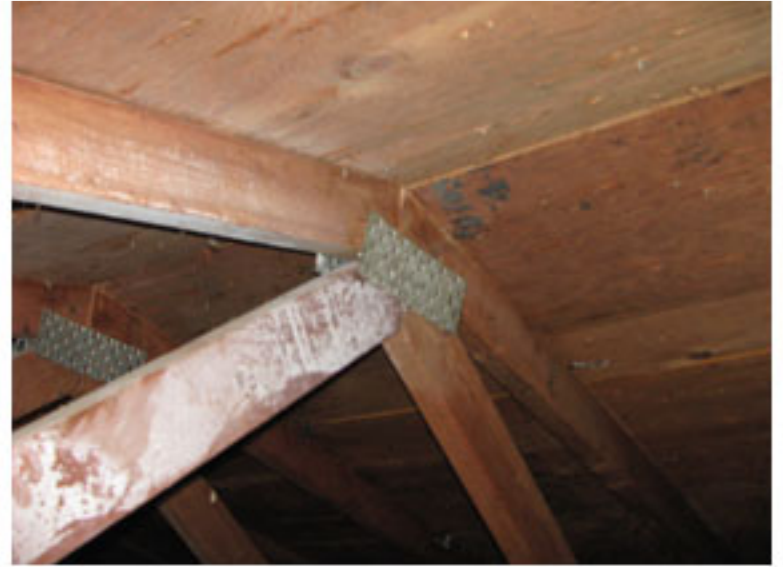
No notable attic decking stains from scuttle access

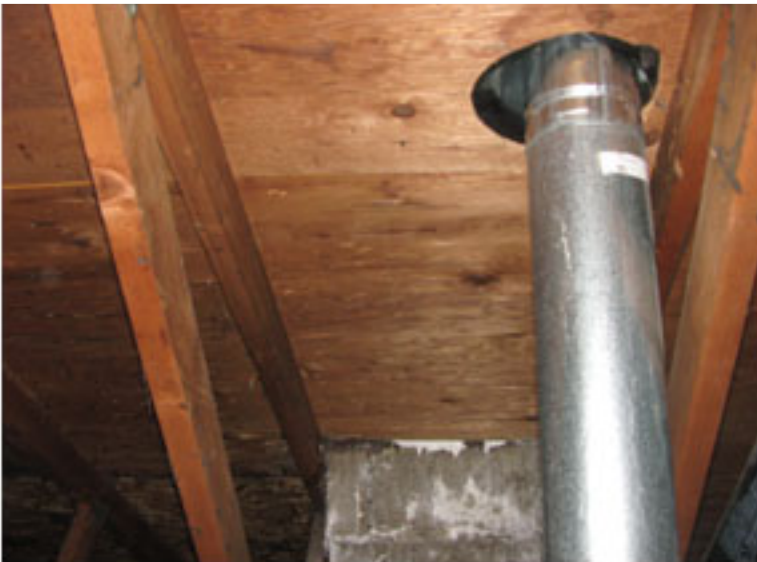
Roof decking from attic

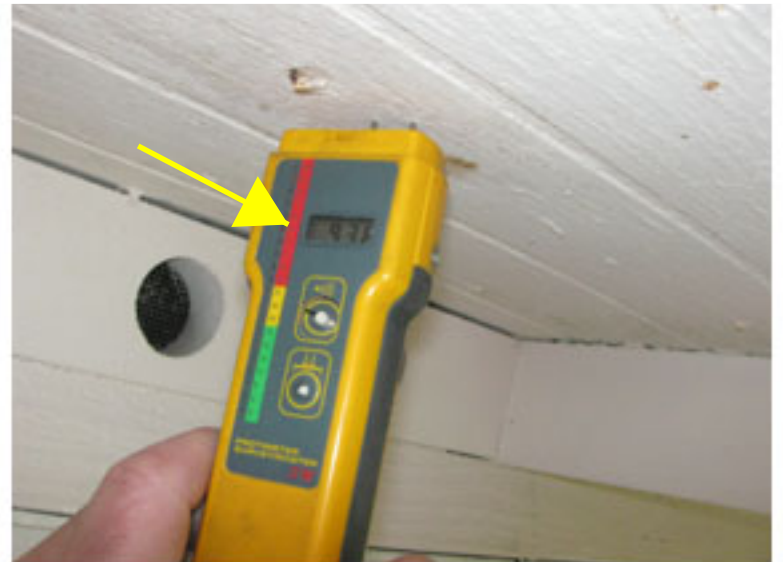
Observations: I found active leaks in the eaves with high moisture readings as shown on the photos (ranging from 70% - 93%). The shingles do not appear to be defective. I found no cracks or visual flaws in them. The leaks are not caused from a ventilation problem. Ventilation has nothing to do with the active moisture in the eaves (as the eaves are open to the air). The roof is a low pitched roof; 3-12 pitch in some places and a 2-12 pitch on parts of the front side. When an asphalt composition roof is used on a low pitched roof, the roof is more prone to leaks. An asphalt composition roof should not be used on roofs that have a lower that 3-12 pitch.

It is my opinion the leaks are from an improper installation. But the exact cause is not known. Many parts of the installation are covered by the roof covering and are not visible.

93% moisture reading in eve

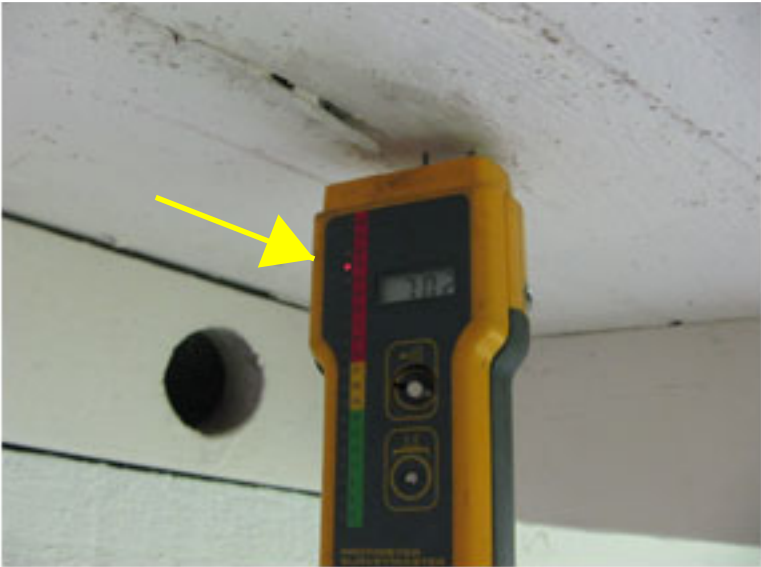
70% moisture reading in eve

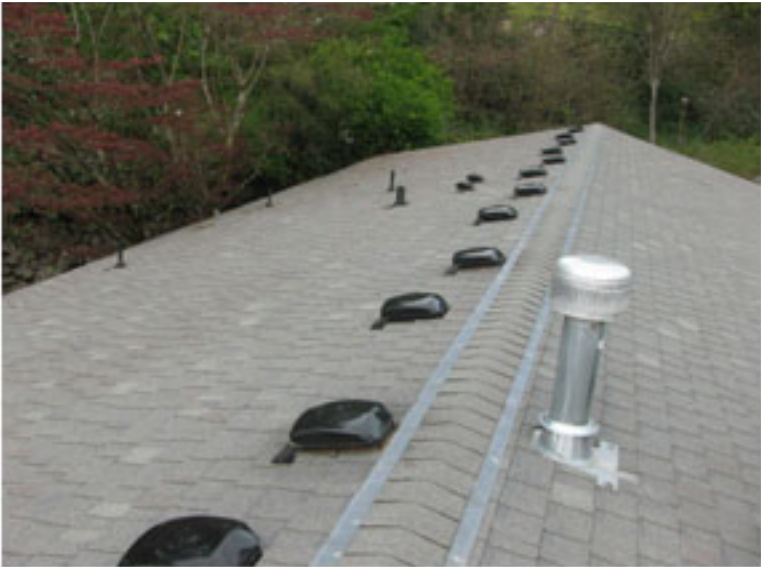
Lots of high roof vents
